Vike kirkeruin

Vike Church Ruins

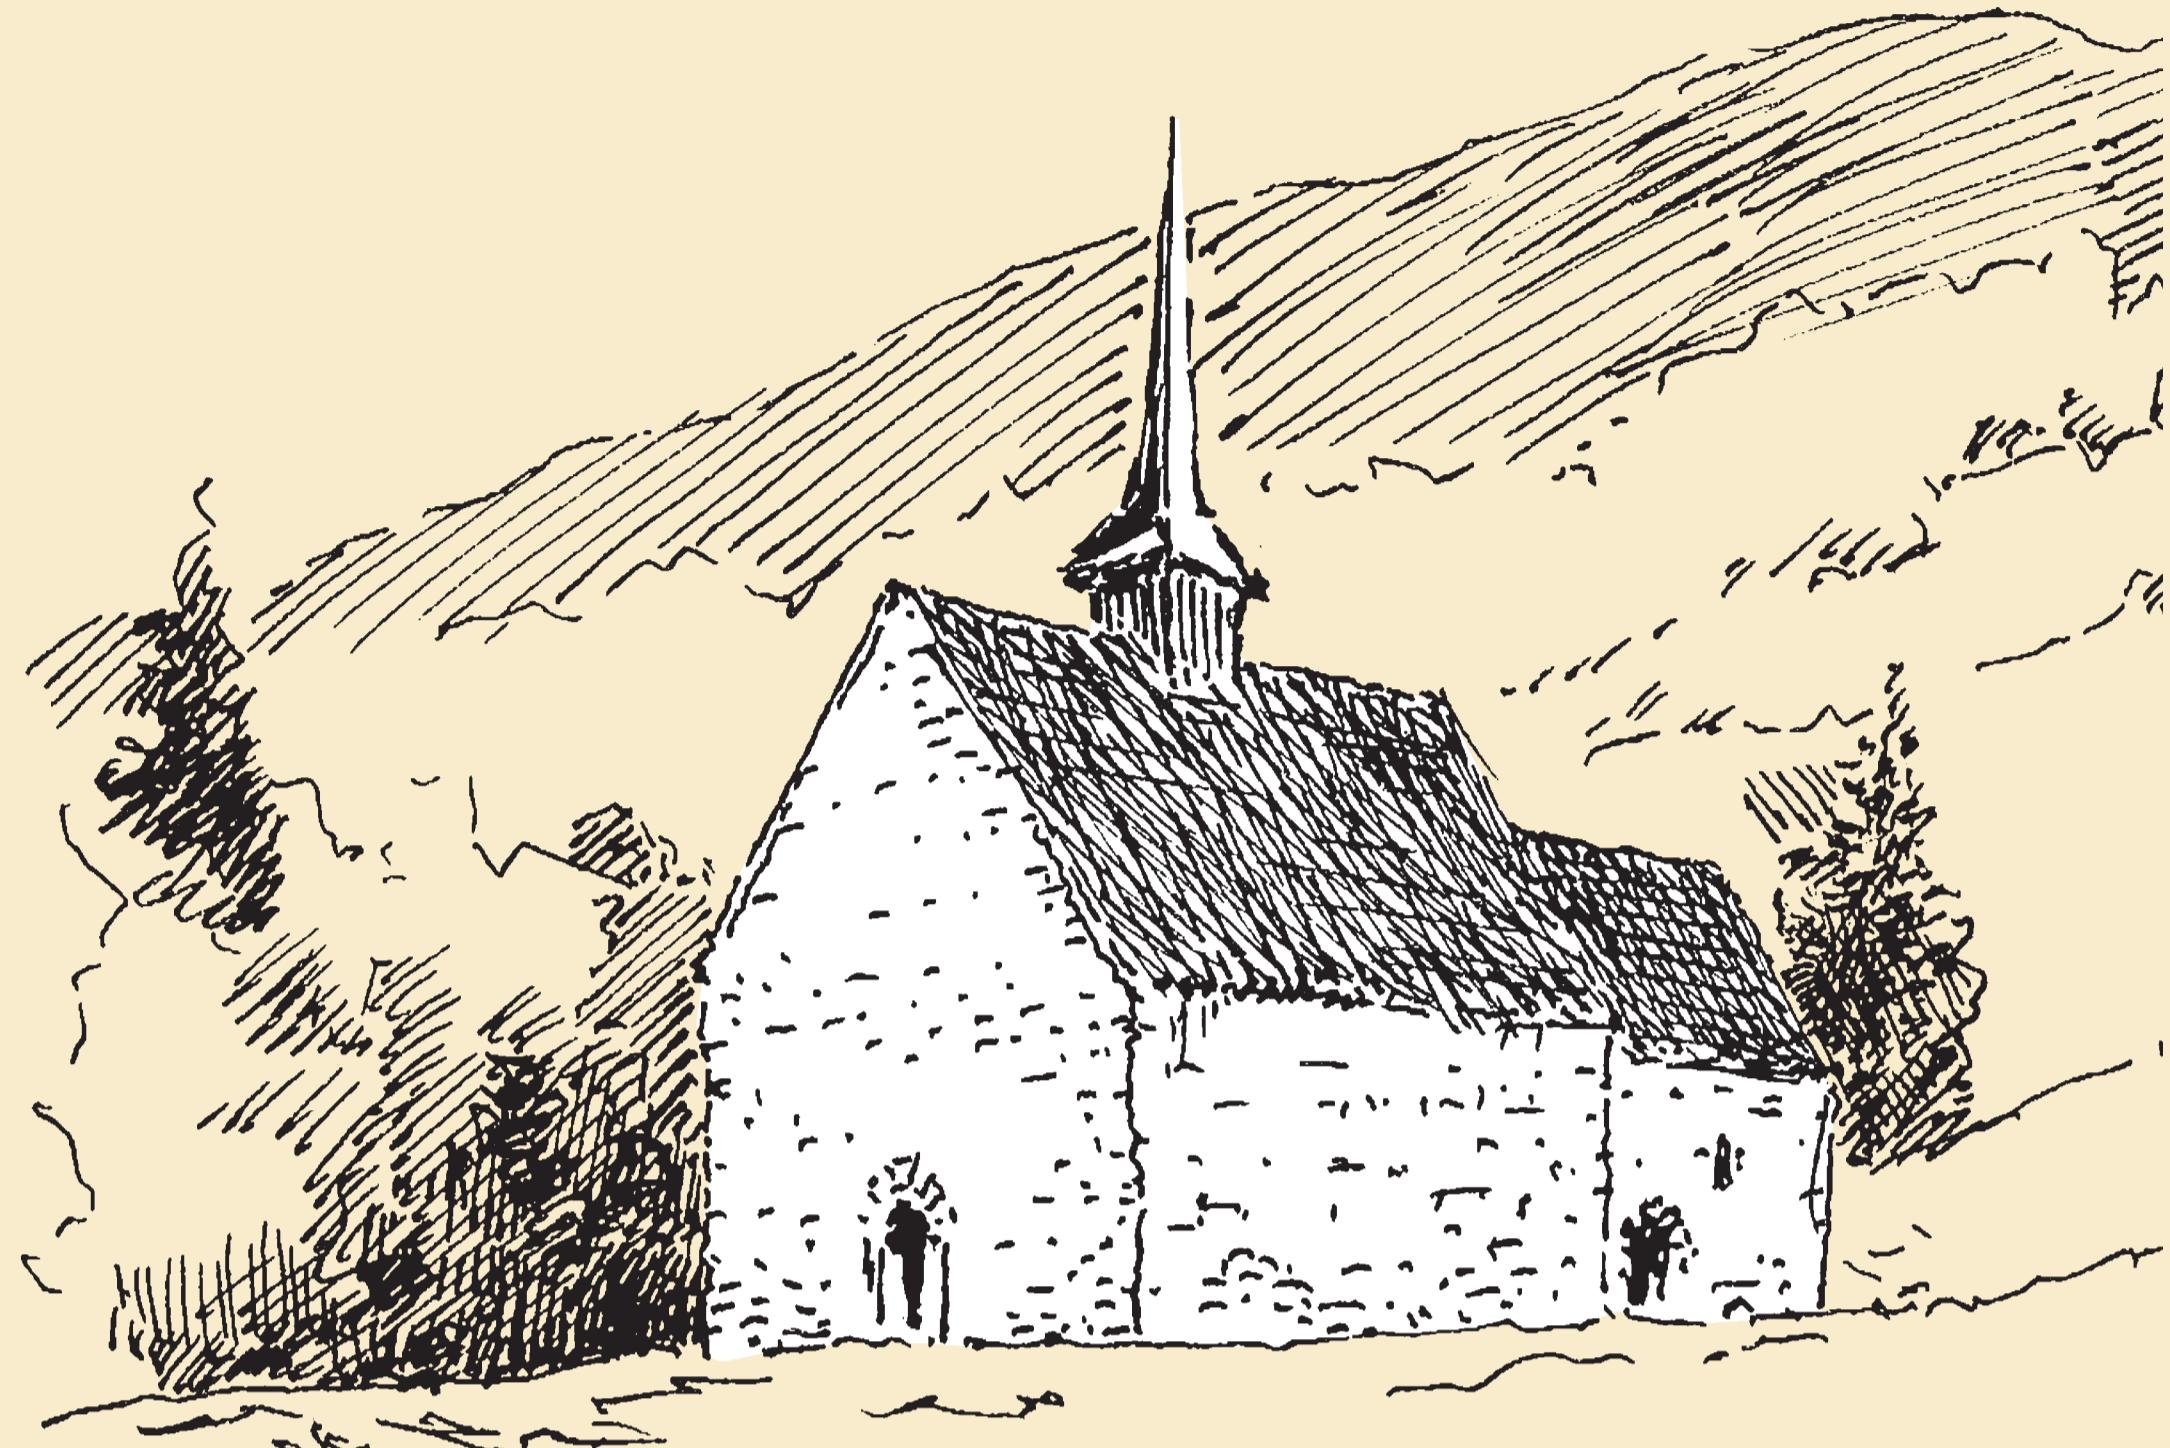
The excavation of the site shows the outline of the medieval church. The nave was rectangular, approximately 15 by 10 metres, while the choir was narrower, approximately 6.5 by 6.5 meters.

Rekonstruksjonen er laget av Geir Helgen.

Utdragningen av kirketuften viser hvordan kirken har sett ut i middelalderen. Den har hatt et rettangulært skip, ca. 15 meter langt og 10 meter bredt. Koret var smalere, ca. 6,5 meter langt og 6,5 m bredt. I skillemuren mellom skip og kor er det en koråpning. Dette kan fortsatt sees. Skipet har hatt en vestportal og inngang i vest. Terskelhellen har slitespor etter menighetens inngang og utgang gjennom tidene. Kirken har hatt et hovedalter ved østmuren i koret, og sidealter på hver side av koråpningen. Fundamentene man kan se ved koråpningen er etter ciborium, en baldakin eller overbygning over sidealtrene. I 1595 ble det nevnt i skriftlige kilder at kirken hadde spir.

The opening in the wall that divides the nave from the choir can still be seen. The nave had a west portal and a main entrance facing west. The threshold flagstone is visibly worn from the passing of the feet of innumerable parishioners. The church had a main altar by the eastern wall of the choir and side altars on each side of the opening into the choir. On each side of the opening you can also see the foundations for a ciborium, a canopy or covering above the side altars. A source from 1595 describes the church as having a spire.

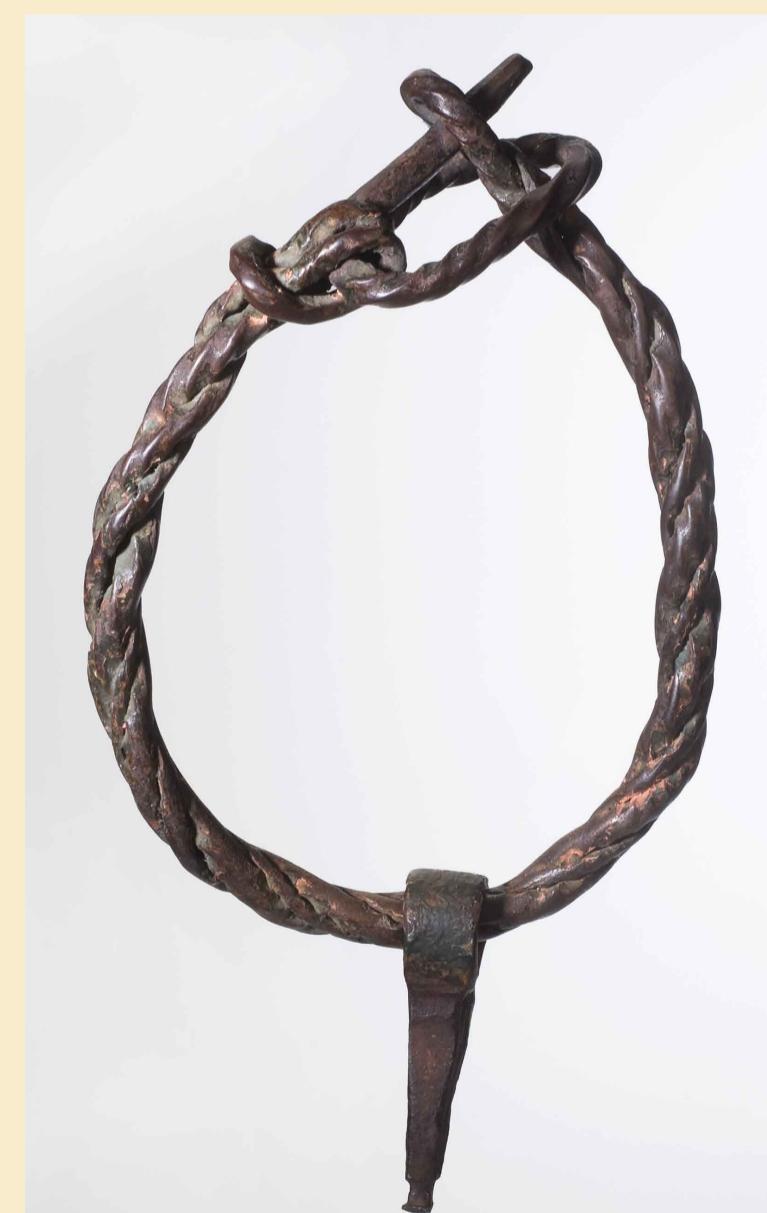
Olavsspenning

Denne olavsspenningen er av smijern. Den er smidd i ett stykke, og kan ikke åpnes. Olavsspenninger har blitt smidd opp mot vår tid, og det har vært flere av disse i kirker i Buskerud. Å smi olavsspenninger er et kunststykke.

This "Olavsspenning" is made from iron. It is forged in one piece, and cannot be opened. Items of this type have been made right up to the present age, and several have been used on churches in Buskerud. Forging an "Olavsspenning" is considered a task for a master blacksmith.

Ringen er en olavsspenning, og har trolig vært festet på kirkedøra i Vike kirke. En olavsspenning er en vidjespenning, en ring ofte laget av bjørkeskudd. Disse ble vridd og lagt dobbelt, slik at det ble en løkke der bjørkeskuddene ble bøyd. Den andre enden var tykkenden, som ble utformet som en lås. Løkken ble tredd innpå. Vidjespenningen kunne åpnes og lukkes i låsen, og har vært brukt der noe skulle festes eller bindes sammen. Låsen kunne gjøres på flere vis. Den fineste låsen hadde navn etter hellig Olav.

This clasp is called an "Olavsspenning", and is believed to come from the door of Vike Church. The term was originally used for withies (supple willow twigs woven together), which in spite of the name were often made from birch shoots. A twig was folded and twisted, forming a loop at one end. The other end was fashioned into a hasp (not unlike a belt buckle), into which the loop end could be fastened. The clasp could be opened and closed, and was used for fastening or tying things together. This type of clasp could be made in a number of ways. The best design was named after Saint Olav, the national saint of Norway.
